EXHIBIT 23

Tire Pressure Sensors

**Technical Bulletin**NISSAN NORTH AMERICA, INC.
Copyright ©**RECALL CAMPAIGN BULLETIN**

**VOLUNTARY SAFETY RECALL CAMPAIGN
ROGUE, MURANO, cube[®]; WHEEL VALVE STEM NUT**

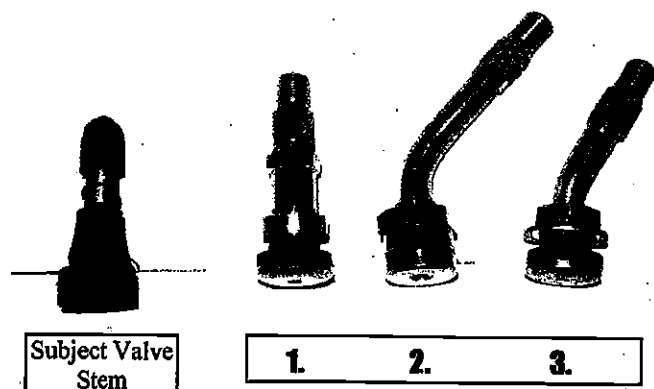
Fleets and owners who have replaced their original equipment rubber valve stems with all-metal valve stems have seen a dramatic reduction in the failure of the valves. One fleet reported switching to a competitor's rubber valve stem rated to 100 psi, with the same result. However, several fleets reported multiple failures of rubber/metal valves and have not had any incidents since switching over to all metal valve stems. ODI has received zero reports of failure of metal valve stems on any of the subject vehicles.

Figure B. The subject valve stem involved in this investigation is shown at left. The three remaining valve stems are, from left. (1) Used on all 2002 MY F350 duallies with aluminum wheels, (2) Used on all 2000+ F450 and F550 trucks with 19.5" wheels. (3) Used on all 2002 MY F340 duallies with steel wheels. These three valve stems are examples of all-metal valves referred to in the text.
