Rebuttal of D. J. Duquette Expert Report
In the Case of
Robert Tomassini v. Chrysler Group, LLC

May 23, 2016
AIM 15018790-4-2

Subject: Rebuttal of D. J. Duquette Expert Report In the case of Robert Tomassini v. Chrysler Group, LLC

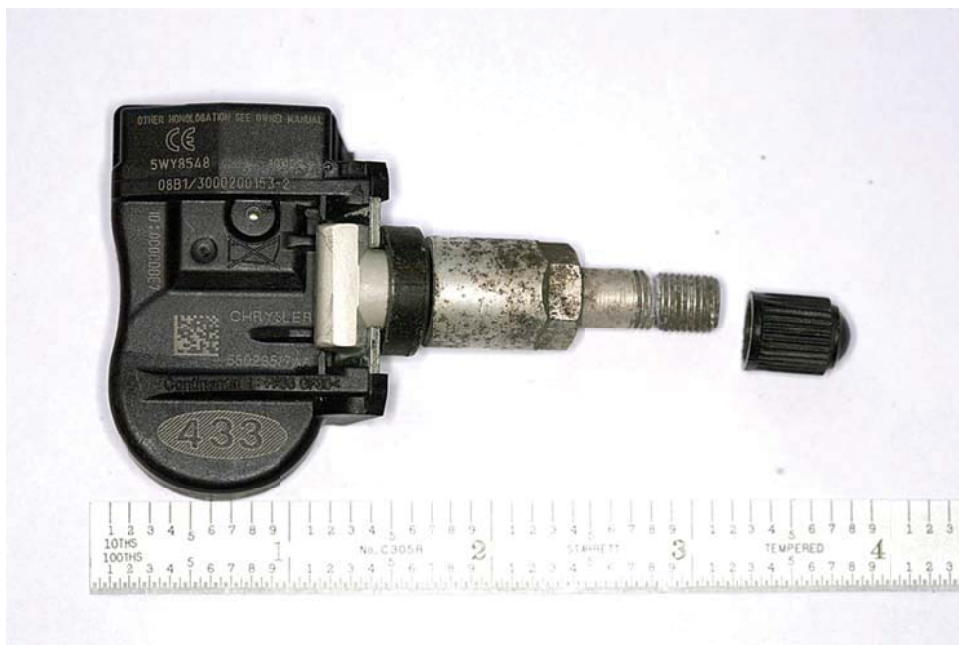
Figure 3-1 — TPMS Device Sample A with Fractured Stem.

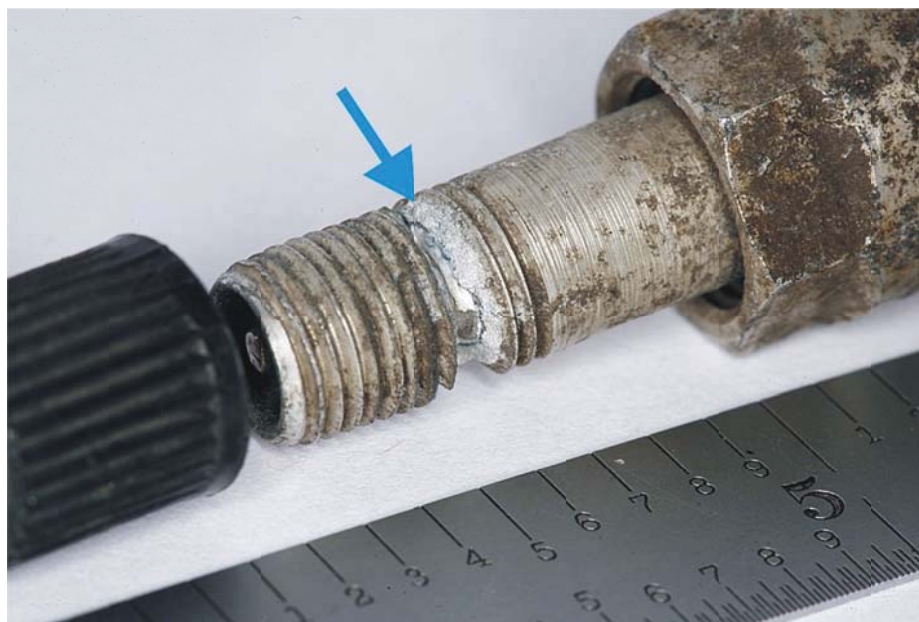
Figure 3-2 — TPMS Device Sample A, Close-up of Fracture (At Arrow).

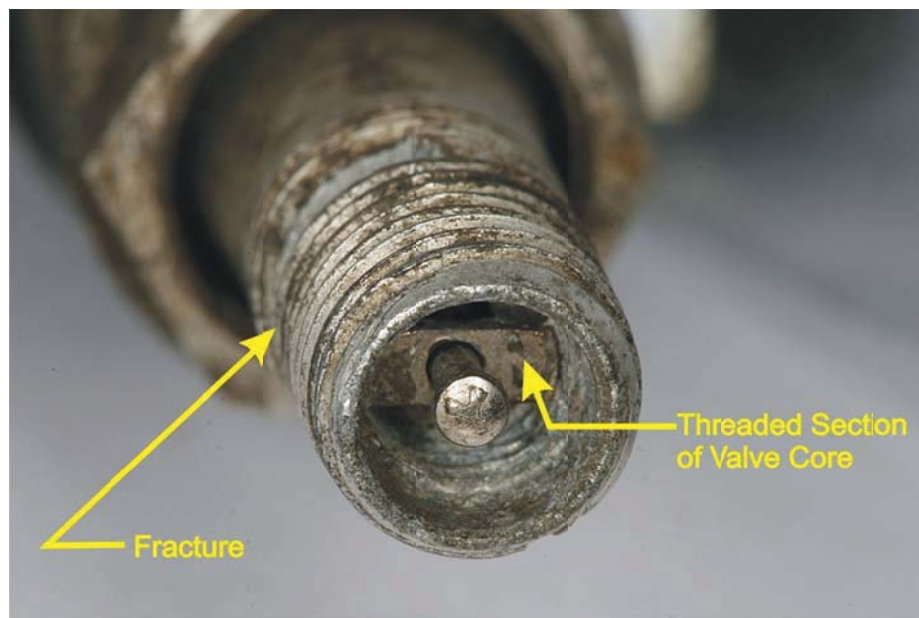
I have concluded that the SCC forms just below the threads of the valve core because it is a location with the highest tensile stress in the valve stem. That tensile stress is present in all of the TPMS valve stems due to the fact that the valve core must be tightened sufficiently in order to prevent leakage. When the valve core is first assembled into the valve stem, it is tightened by the manufacturer to prevent leakage. Duquette presents no evidence that Chrysler over-tightened or under-tightened any of the valve cores of any Chrysler vehicles.

Figure 3-3 — TPMS Device Sample A, Close-up of Inside Surface.

NOTE: The fracture occurred just below the threaded portion of the valve core, a location that will have relatively high tensile stress due to reduced wall thickness in the threaded region. There are both internal threads and external threads at the location of cracking.

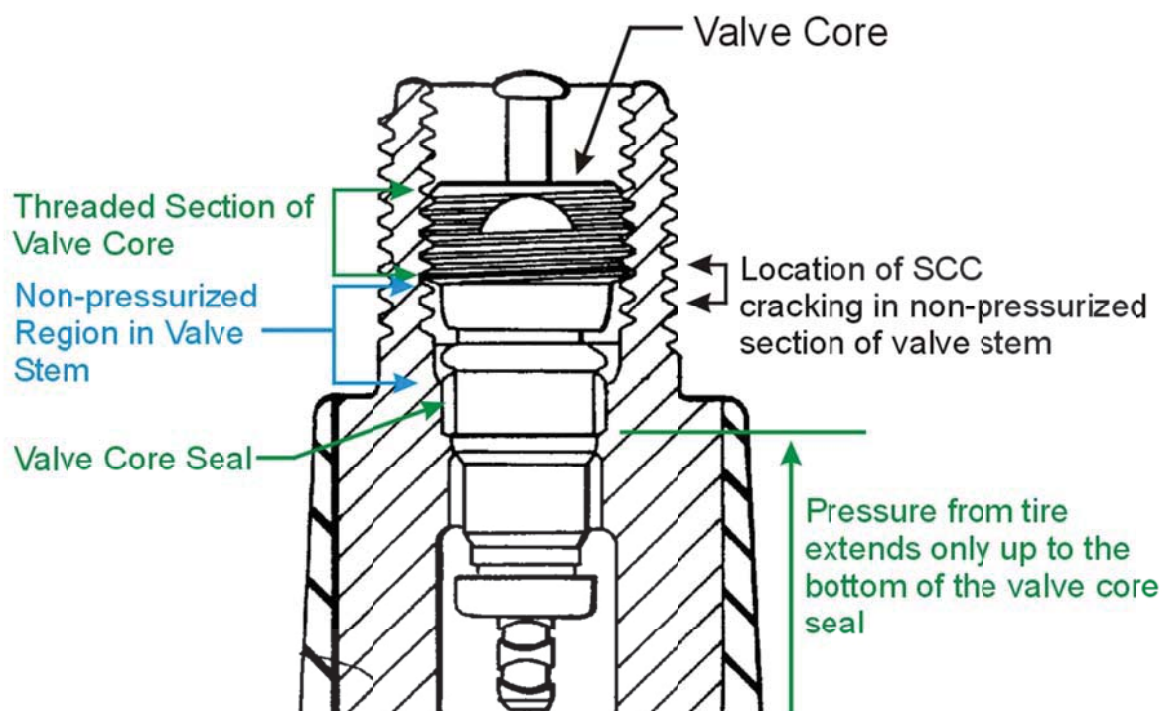
A simple analysis of the forces involved shows that a tensile stress is developed in the valve stem, but only in the region between the valve core threads and the valve core seal. That is also the thinnest region of the valve stem due to the presence of both internal and external threads. The pressurized region of the valve stem exists only below the rubber seal of the valve core. The diagram in Figure 3-4 illustrates this condition.

Figure 3-4 — Illustration of Valve Core and Pressure Boundary Within Valve Stem.

NOTE: Tightening the valve stem results in tensile stress in the valve stem wall, but only in the region between the valve core threads and the valve core seal. All SCC cracking failures of the TPMS valve stems has been observed only in the region between the valve core threads and the valve core seal.
