# EXHIBIT 14

TPMS – Tire Guard Wheel Unit  
TG1B  
Mechanical cracks on valve stem

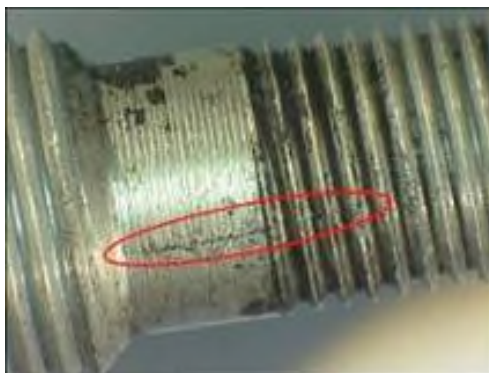
- Field returns showing longitudinal cracks or broken valve stems.

Longitudinal Cracks

- Stop aluminum 2011 with T6 thermal treatment and use only aluminum 2011 with T4 thermal treatment.
- Qualify aluminum 6082 (copper <0.1% - non susceptible to corrosion).
- Reevaluate validation requirements and define a more robust test procedure.

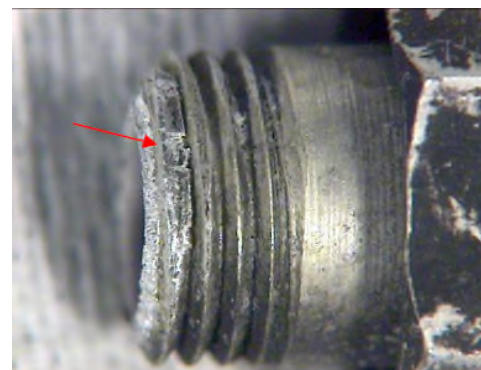
Broken valve nose

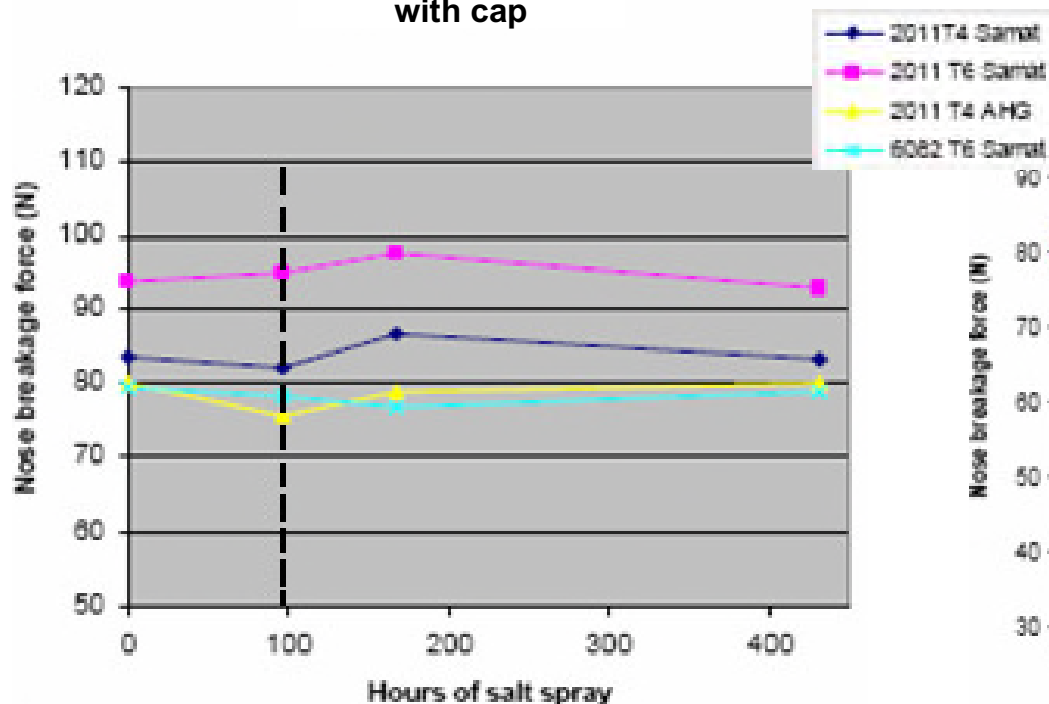
**with cap**

Valve core assembled **as per** Continental Specification **0.4 Nm**

Nose breakage test performed on 10 parts each at 0, 96, 168 and > 400 hrs of exposure to the environment

**No change on the mechanical resistance**

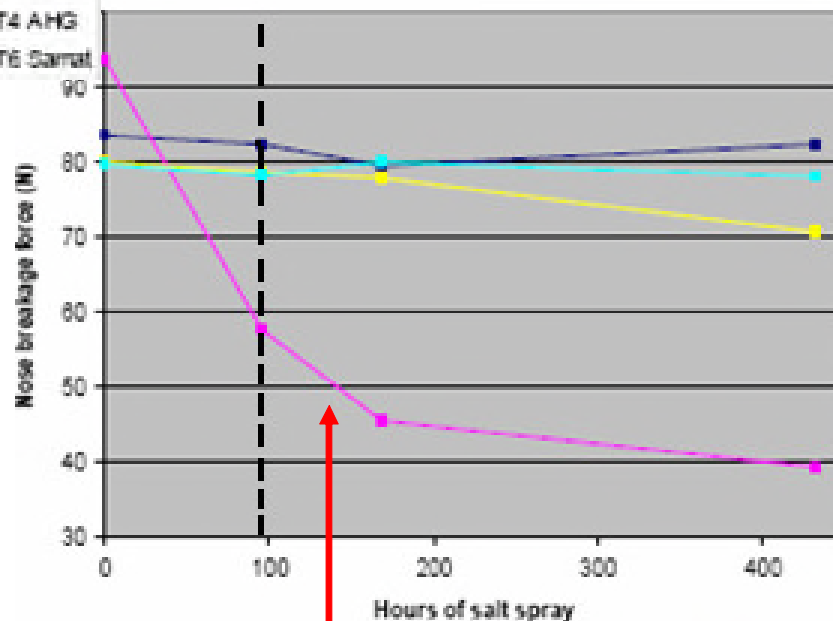
**without cap**

After 400hrs of Salt Spray the valves with aluminum 2011 and **heat treatment T6** have **lost more than 50%** of their initial mechanical resistance.

The aluminum 2011 with T6 lost more than  $>50\%$  of it's mechanical resistance after 400hrs of Salt Spray when tested without cap

➤ The influence of the presence of the cap can be clearly seen on the SAMAT T6 parts, a force of 40 Nm was required to break the valve nose after 400 hrs of exposure to salt spray without the cap.

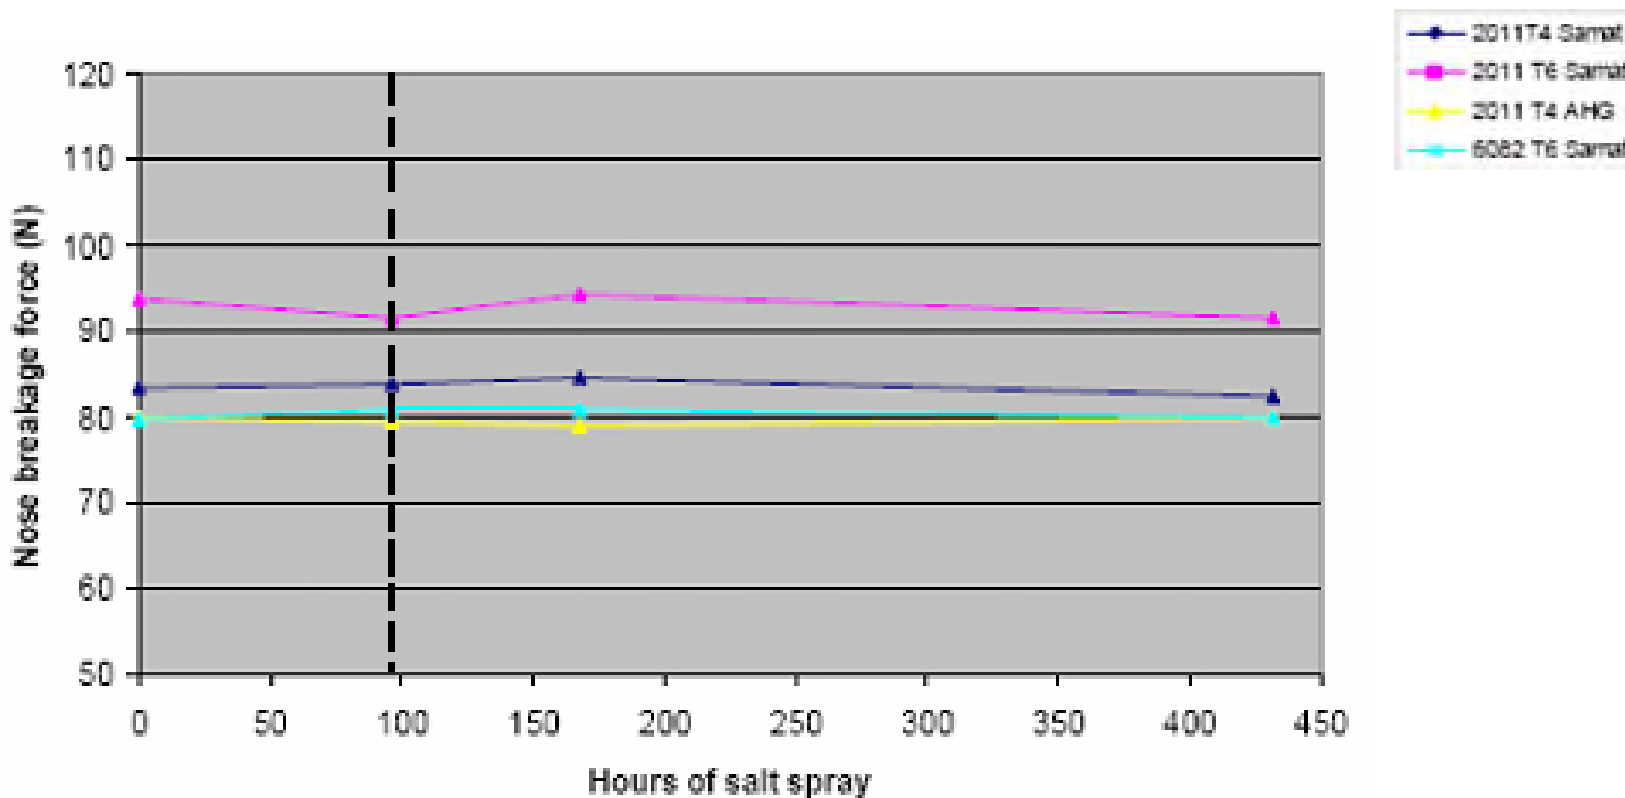
Valve core assembled **outside** of Continental Specification **1 Nm**

**No change on the mechanical resistance**

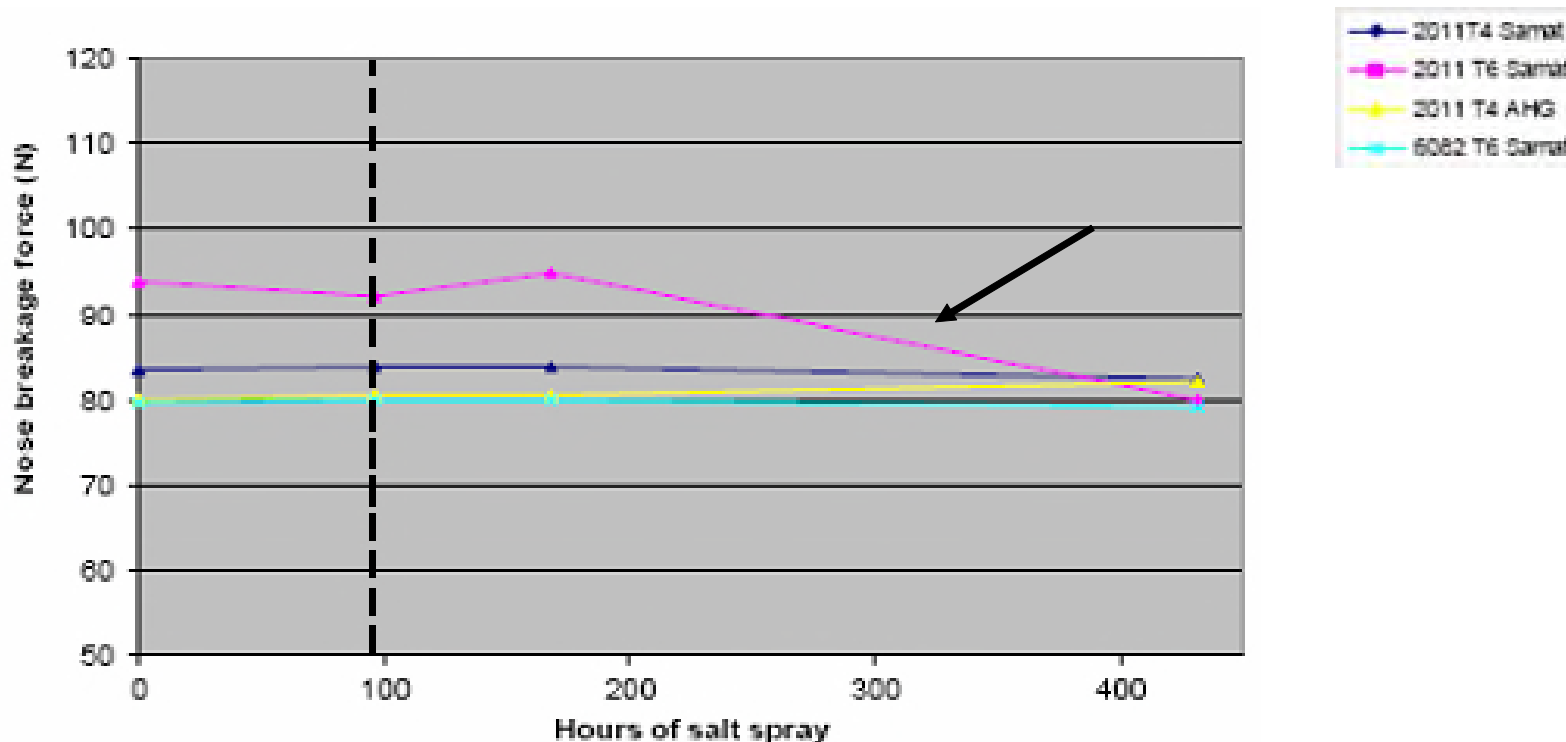
Valve assembled **outside** of Continental Specification **1.2 Nm**

After 400hrs of Salt Fog the valves with aluminum 2011 and heat treatment T6 shown a slight decrease ( $\approx 15\%$ ) of their initial mechanical resistance.

No change on the mechanical resistance of the other parts.

The aluminum 2011 with T6 had a slight decrease ( $\approx 15\%$ ) on the mechanical resistance after 400hrs of Salt Spray when tested with excessive torque

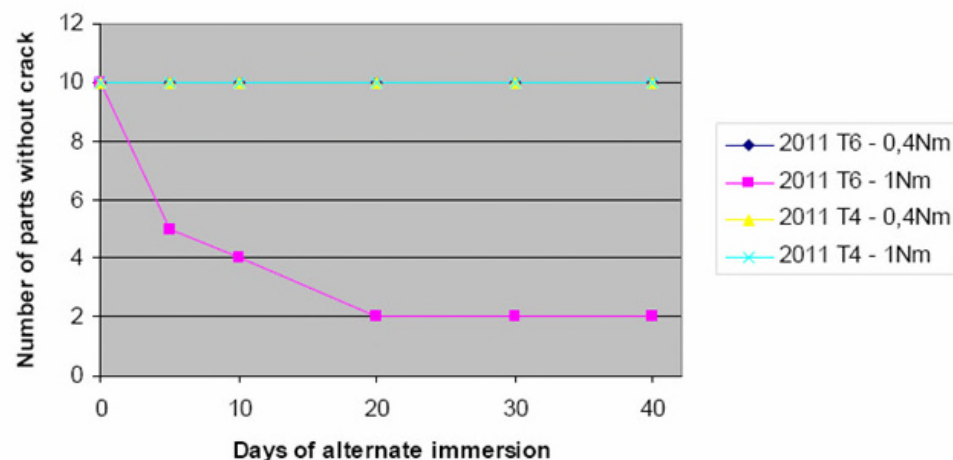
## ➤ Parts without cracks

Parts mounted with cap & valve core at 0.4Nm

Parts mounted with cap & with valve core change during the test (0.4Nm)

**SIMULATES TIRE CHANGE  
ACCORDING TO SPEC**

- 2011 T4 SAMAT
- 2011 T6 SAMAT
