EXHIBIT 23

Tire Pressure Sensors

**Technical Bulletin**NISSAN NORTH AMERICA, INC.
Copyright ©**RECALL CAMPAIGN BULLETIN**

**VOLUNTARY SAFETY RECALL CAMPAIGN
ROGUE, MURANO, cube[®]; WHEEL VALVE STEM NUT**

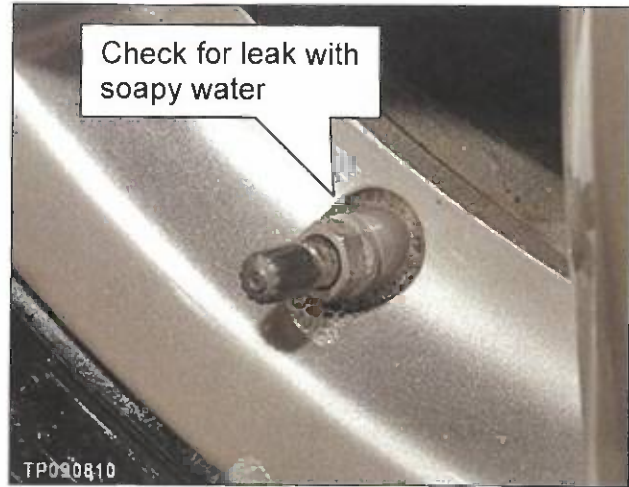
Figure 3

- Apply soapy water around the valve stem.
- Use mild liquid hand soap mixed approximately 80% water and 20% soap.
- Wait a minimum of five minutes and then visually inspect to see if bubbles are forming around the base of the valve stem.
- If you see bubbles, there may be an air leak.

NOTE: This bulletin does not cover repairs for air leaks. If you discover an air leak, repair as needed with usual warranty repair procedures.
